Phase One
Environmental Site Assessment
Of
W ½ Sec 2, SE Sec 2 , SE Sec 3 Twp 33 Rge 1 W5M
Olds, Alberta

Prepared For : **Brown & Associates Planning Group**
Prepared By : Base Property Consultants Ltd.
Date: April 30, 2008

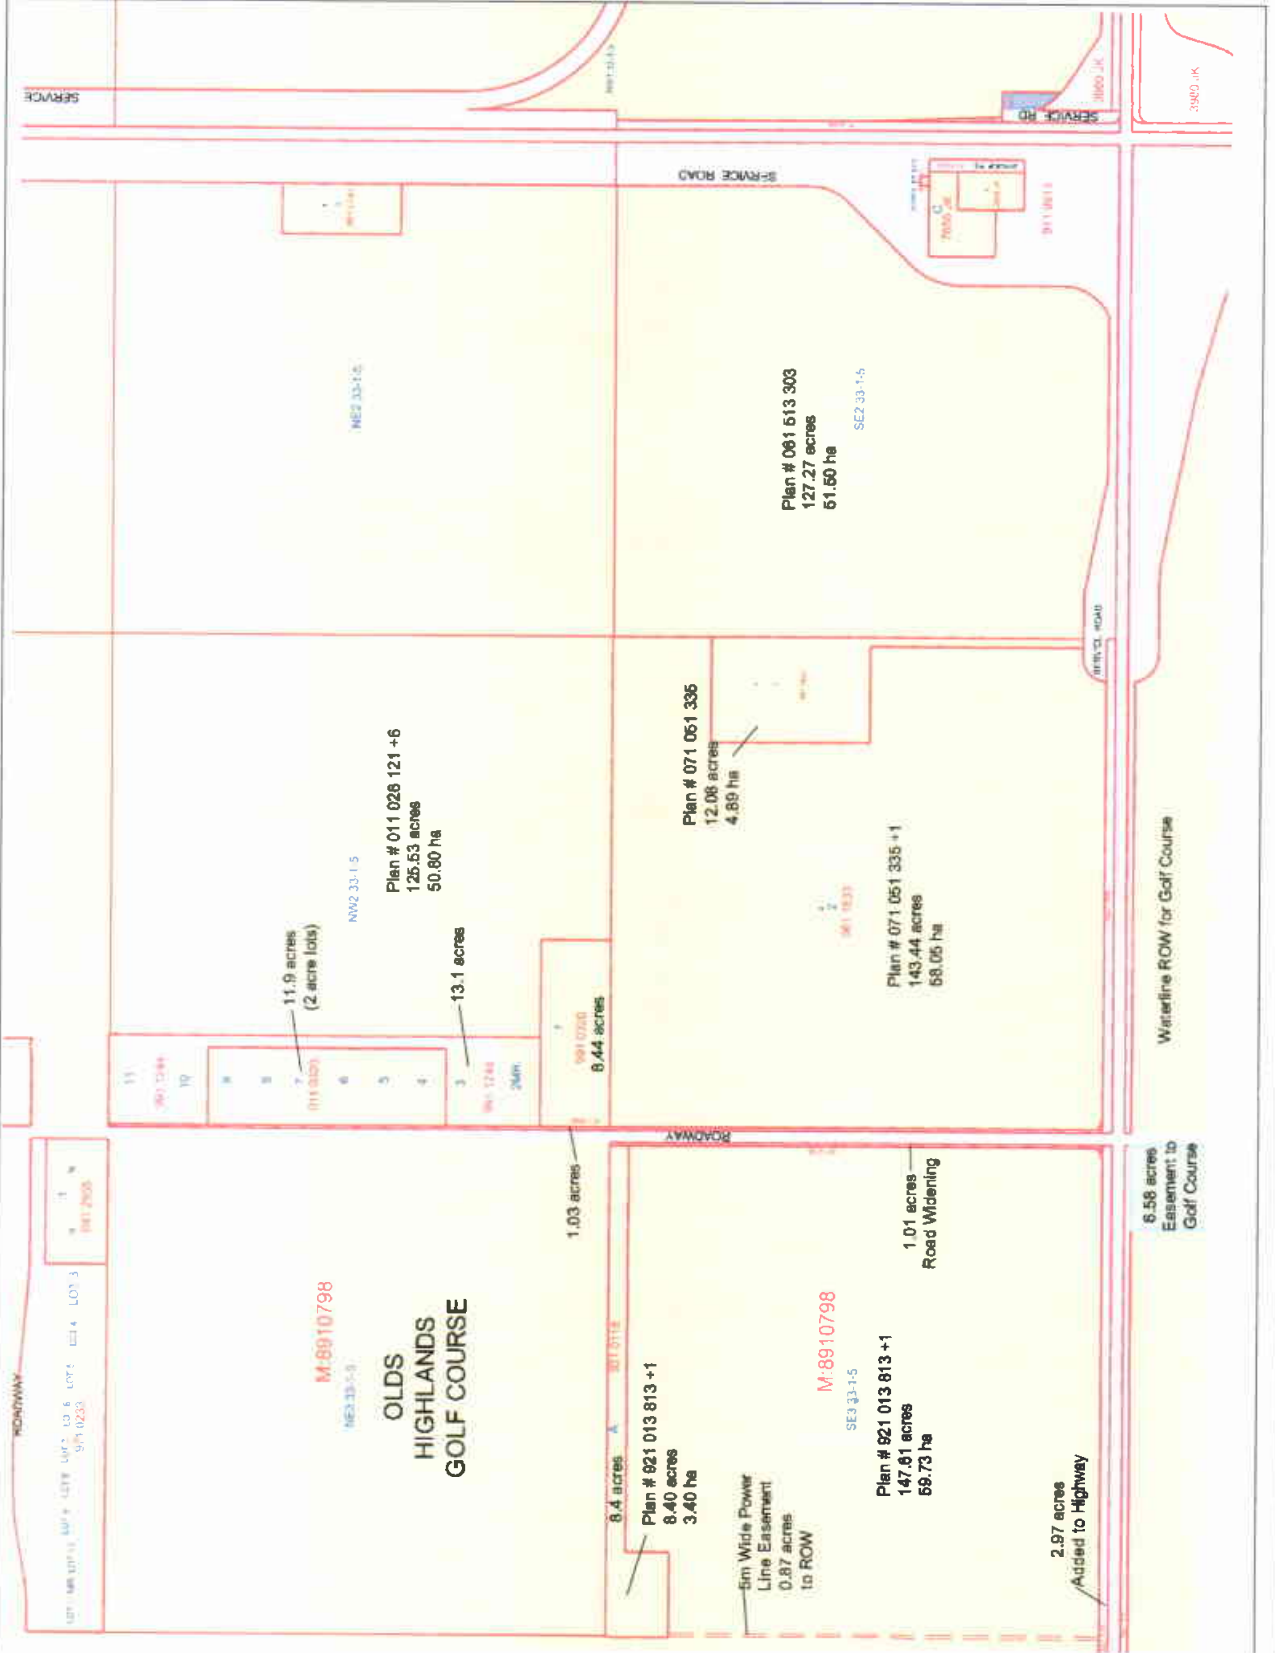
**MOUNTAINVIEW
MEADOWS
BUSINESS PARK
& RESIDENTIAL
COMMUNITY**

**Legal
Descriptions**

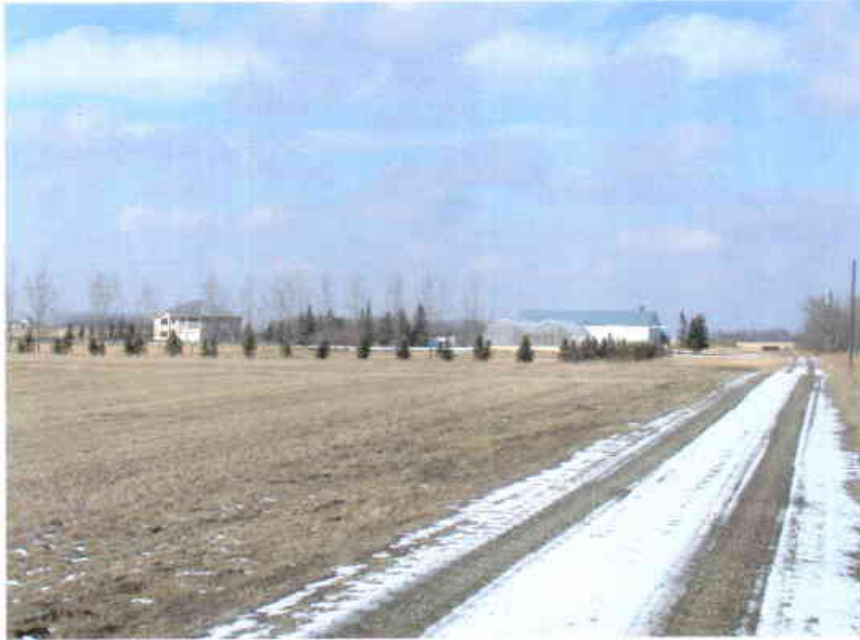
Photo One – View of SW2 Farmstead Looking Northwest

The farmstead on the SW2 is serviced by a water well and two septic sewer systems. The house has an attached double garage. Windows in the house are construction date stamped 1996. The quonset/greenhouse includes a mezzanine residence. The quonset has a gravel floor with no floor pits or drains. The greenhouse has floor drains connected to an external dry well to the south. A steel dumpster is located between the house and quonset and is used for solid waste disposal. Two dugouts are located north and south of the house. These dugouts collect surface drainage water and water from pipes draining a slough area to the north. A steel above ground fuel storage tank (AST – approximately 454 l) is located northwest of the quonset. No obvious spills or leaks were noted beneath this tank.

Because the farmstead buildings on the SW2 were built after 1995 they are not likely to contain any regulated substances such as lead-based paints, asbestos containing construction materials and fluorescent light fixtures with PCB's in their ballast. An AST was observed on the SW2 farmstead but no above ground fuel storage tanks (ASTs) were observed on the SE2, they may have been on that property in the past. When the AST on the SW2 is no longer required and when the SE2 is redeveloped, should any stained or noxious soil be encountered during site development then Base Property Consultants Ltd. should be contacted to determine the appropriate use of this material. No obvious signs of uncontrolled dumping were observed during the site reconnaissance. Historical air photos show a surface disturbance at the northwest corner of the SW 2 in 1988 and 1990. No obvious sign of this disturbance was noted during the site reconnaissance. Should any buried foreign materials, buried organic soil, stained or noxious smelling soil be encountered during site development then Base Property Consultants Ltd. should be contacted to conduct further investigation.

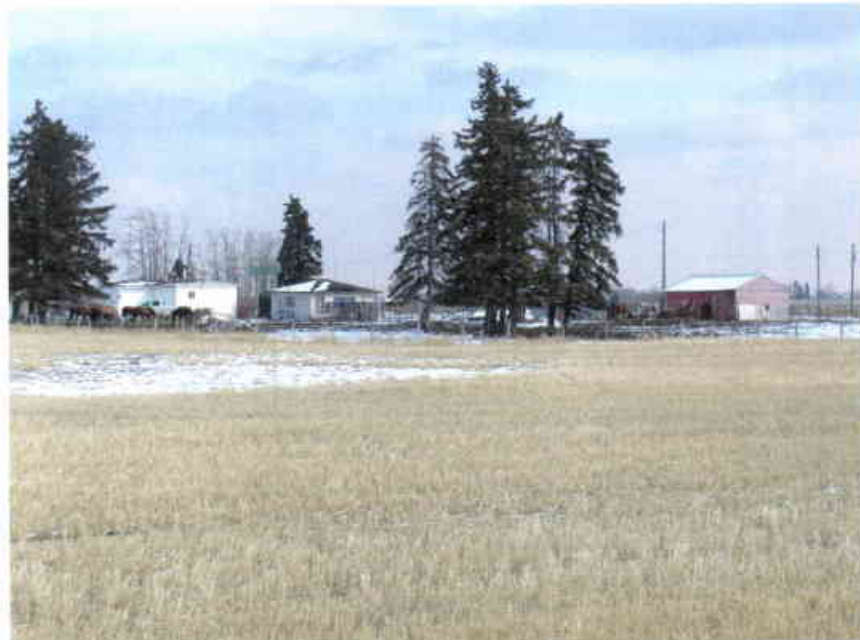
Photo Two – View of SE2 Farmstead Looking Southeast

The farmstead on the SE2 is serviced by a septic system and water well. No obvious signs of refuse or burn pits was observed. The detached garage was not available for viewing. No obvious signs of the former farmstead buildings was observed. The service station to the southeast of the SE2 has underground storage tanks (UST's).

No obvious sign of the former farmstead buildings on the SE2 was observed during the site reconnaissance. Heating fuel oil facilities, demolition refuse, burn or garbage pits are typical features of country residences. No obvious sign of such facilities were observed during the site reconnaissance. Should any buried foreign materials, buried organic soil, stained or noxious smelling soil be encountered during site development then Base Property Consultants Ltd. should be contacted to conduct further investigation.

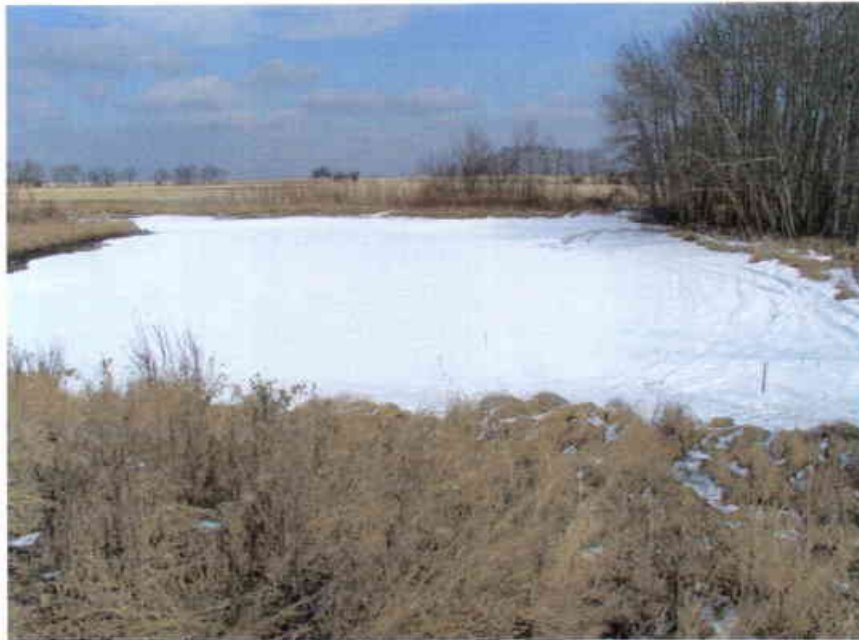
Photo Four – View of Dugout in NW2 Wood Lot Looking East

willows) in the southeast corner of the NW2 and planted trees, shrubs and grass around the farmsteads in the SW2 and SE2. The wood lot has a dugout at its southeast corner. There were no obvious signs of uncontrolled dumping observed on the property.
